Escape of Oil – Claim case studies

CILA Property Special Interest Group

January 2020

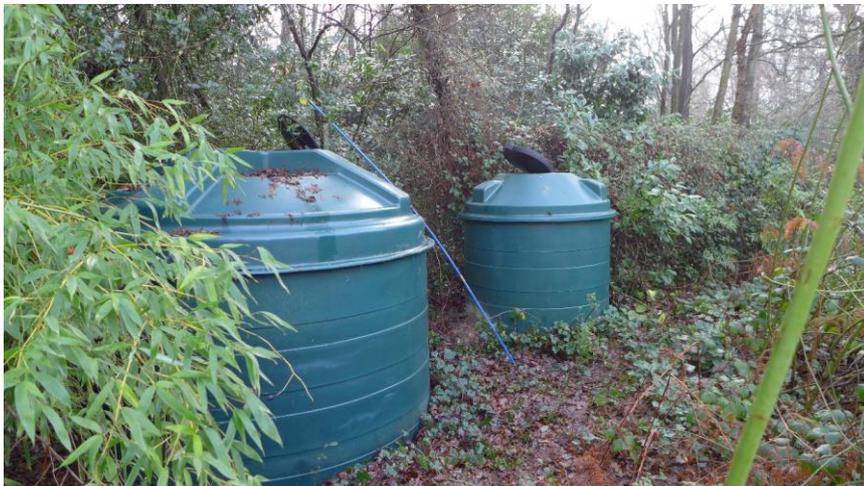
Originally a 2,500 litre tank was present (the right hand tank) and following the construction of the swimming pool and the oil being used too quickly a second 5,000 litre tank was installed.

The tanks were sited on concrete slabs, laid onto compacted soil (all pre OFTEC regs. – see Note 1)

Between the two tanks was a fuel supply line, being a 28mm copper pipe at approximately 30cm above ground level. The site has a high water table and a clay based sub-soil meaning often the ground is subject to high levels of saturation. Both tanks had settled over time, the differing weights of each storage vessel allowing the larger 5,000 litre tank to settle more.

The hypothesis is this led to the separation of the fuel supply line between the tanks and resulted in the 5,000 litre tank fully discharging to ground and some of the 2,500 litre tank also discharging.

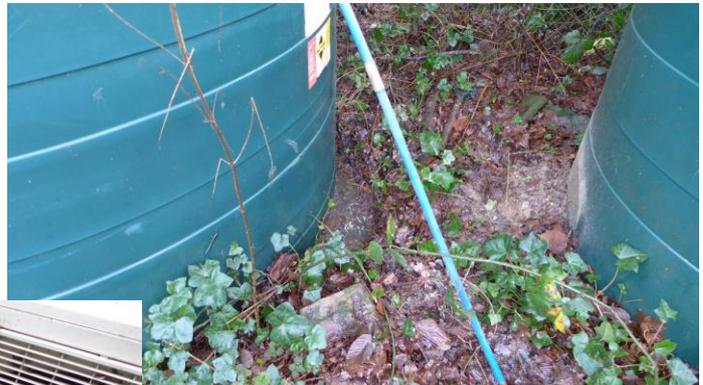
Product (kerosene) was visible in high concentration around the base of both tanks, in pooled ground water.

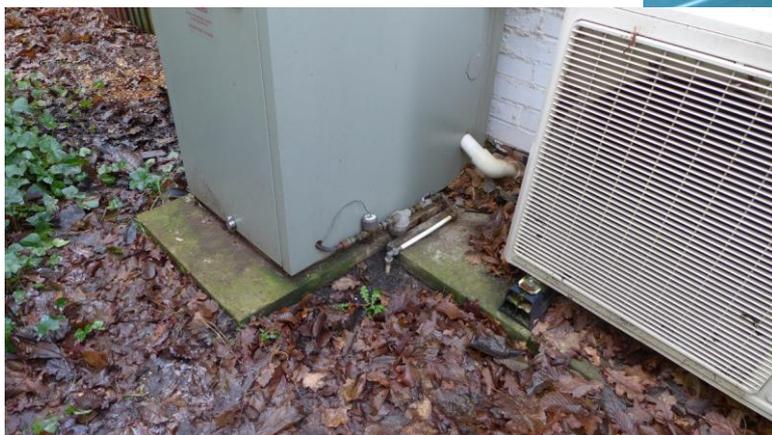
Product was also visible around the perimeter of the main dwelling, with an oily/rainbow coloured residue able to be seen in the ground water sitting amongst

detritus of fallen leaves and the pea shingle driveway beneath.

The kerosene was also very readily smelt in the air around and inside the property.

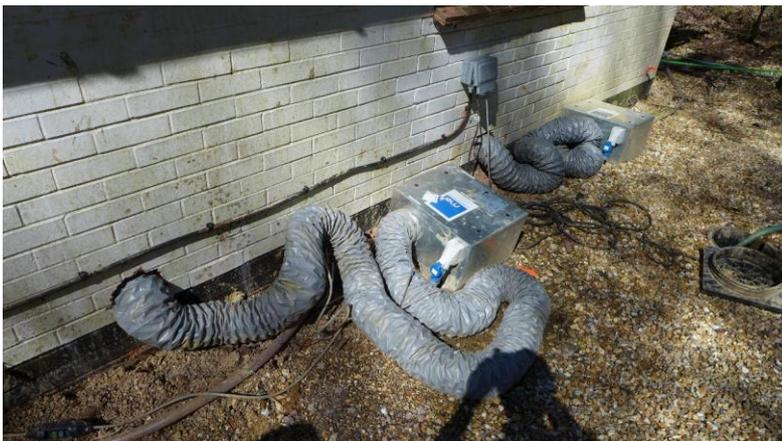
Containment trenches are a common way of preventing oil spreading, the aim being to interrupt and contain the movement of oil across the insured site, thus breaking the pathway.

A vapour extraction kit was installed in the main dwelling, in order to promote air-exchange to reduce the odour that kerosene gives off; the odour is referred to as Volatile Organic Compound (VOC) and is measured in this unit of reference.

The image shows vapour extraction units, note ducting had to be core-

drilled through the structure in order to vent out the contaminated, odorous air.

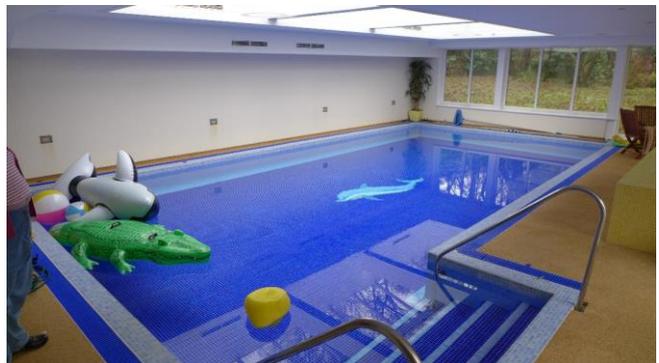
The indoor swimming pool room had a suspended block and beam concrete floor around the pool structure. The nature of this design meant that the void allowed a significant volume of kerosene to come to rest in this area, with the pool structure acting as a containment barrier.

The oil remediation contractor was able to take up localised sections of the block and beam floor to access to the void beneath. Accumulated oil contaminated sediment/sludge was manually removed

for disposal and the exposed sub-floor structures were cleaned and treated using a hydrocarbon degrading surfactant. The only reinstatement was to the final floor finish around the pool area.

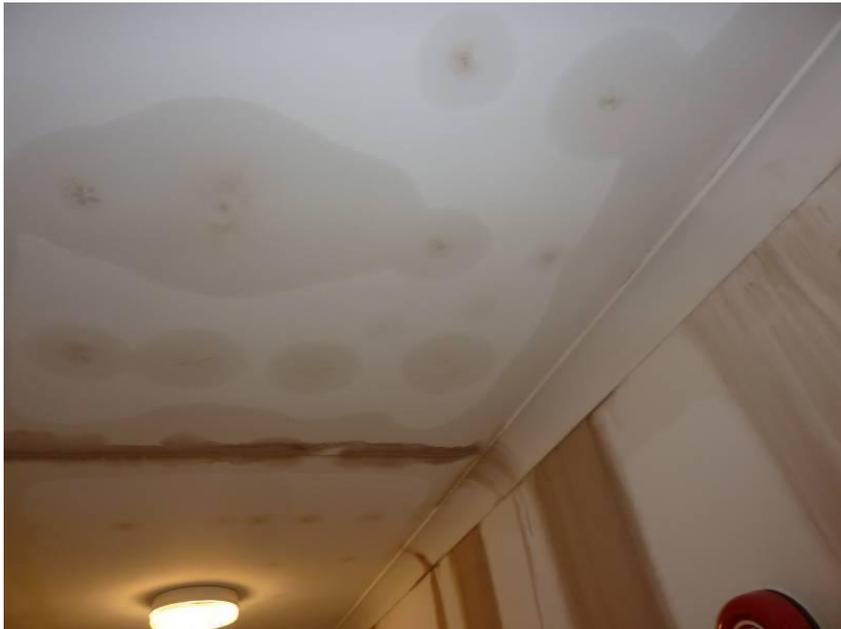
Oil escaped from the plant room tank over a weekend, when the premises were largely unoccupied, and was not discovered until the Monday morning when tenants arrived. During the previous Friday afternoon an oil supplier had made a delivery of some 2,700 litres of heating oil into the main oil storage tank in the rear car park area.

When employees of one of the tenants arrived on site they were immediately aware of the stench of oil, and visible brown sludge covering the ground floor carpet. Elsewhere, other floors showed evidence of the leaking oil, as did many ceilings.

Aside from proactive action and the early engagement of experts, this claim demonstrated the value of thorough cause investigation. Forensic examination showed that contractors had incorrectly calibrated the oil based heating system. The auto shut off mechanism then failed, causing the serious escape. A subrogation action was pursued by the Insurer, with the majority of the loss successfully recovered from the third party contractor.

Oil remediation experts were immediately introduced to assist in mitigating the loss. They proceeded to restrict the spread of the oil as best they could. Insurers recommended that the policyholder engage building surveyors known to have experience of oil remediation. Further experts were engaged to provide materials testing, and mechanical and electrical engineers and structural engineers were also appointed to assist in establishing the extent of damage to services and to the structure.

Carpeting and furniture, wall coverings and contaminated plaster were removed, and intrusive investigations commenced to establish the extent to which oil had penetrated the concrete floors and the hard-core beneath the building. Boreholes were dug through the internal floors and externally, and the number and extent of the boreholes was increased when it was found that oil was entering a water course on adjoining land. The authorities were duly informed.
