**Root Cause Analysis**

#### **BLADE FAILURE**

Wolverhampton – UK, 2011

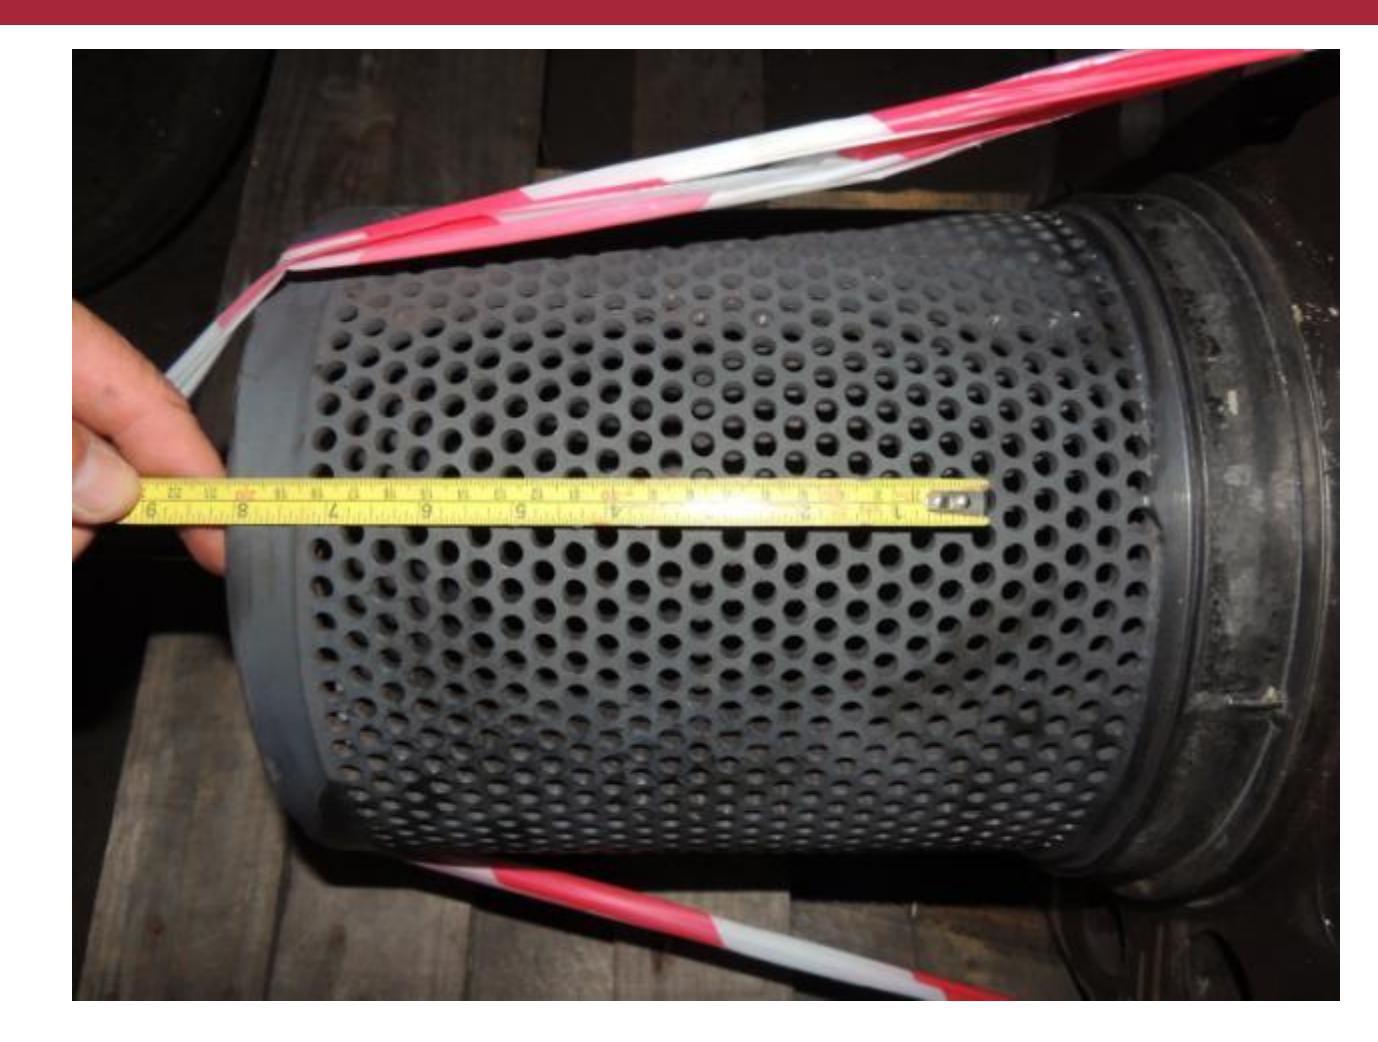
#### **Steam Inlet Screen**

Sample Number and Location	Description	SEM EDX Identification	Most Likely Source	
	1) Steam input screen	Flaking deposits	Mostly iron oxide	Steel corrosion

- The erosion of the low pressure blades is due to debris from steel corrosion and silica particles being transported by the steam.
  - We identified that the input screen for the steam to the turbine had relatively large openings (~6.5 millimeters) and would not be capable of capturing small particles carried in the steam.

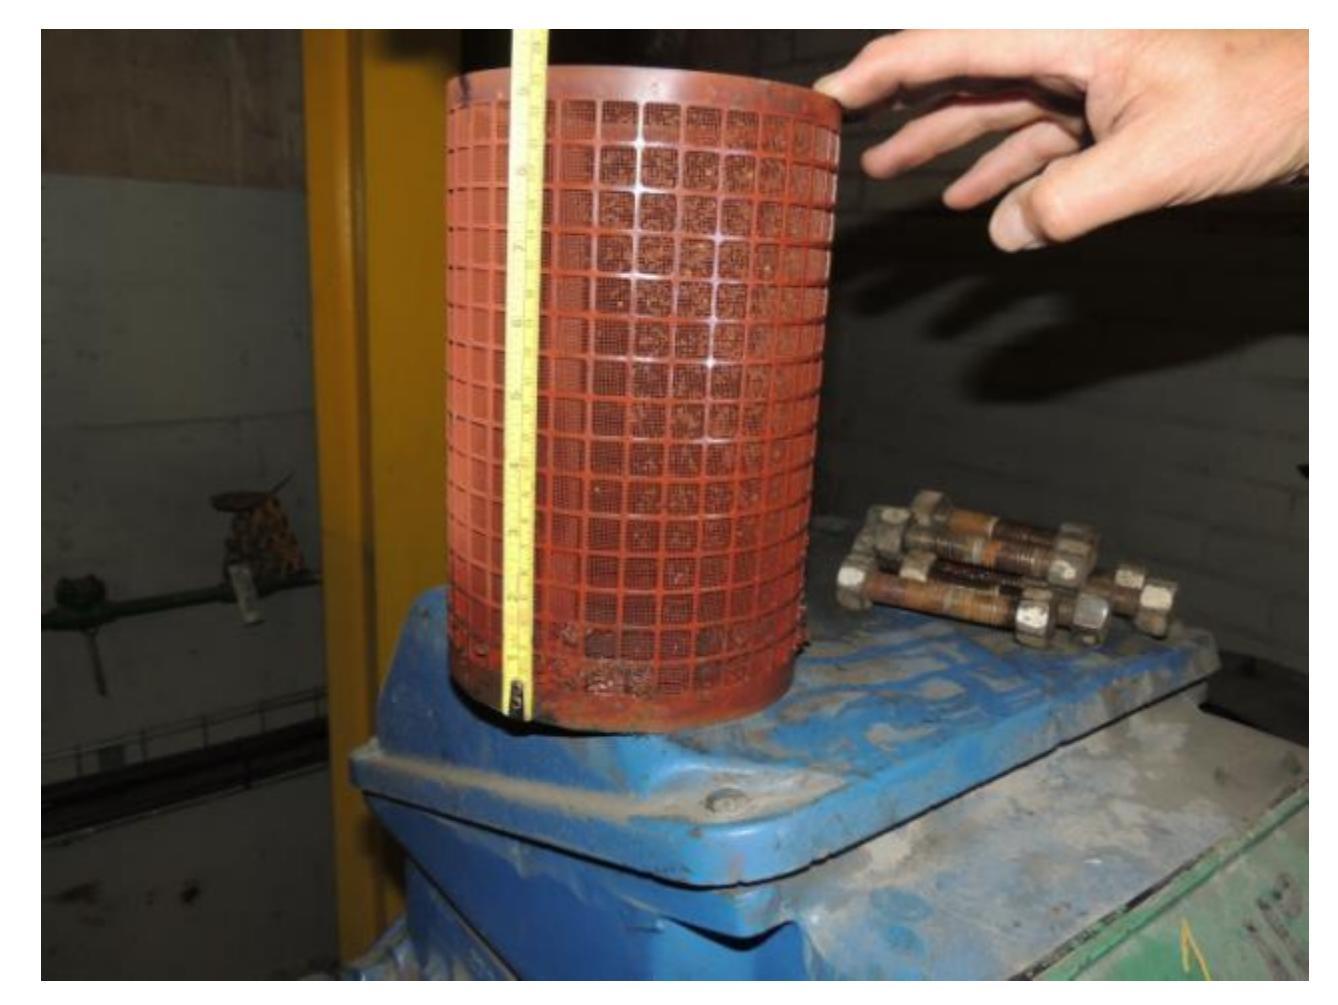
#### **Boiler Water Feed Pump Filter**

5) Boiler feed pump filters	Debris particles	-Mostly Iron Oxide (2x3mm)	-Steel corrosion	
			-Some particles of stainless steel	-Stainless steel wear particles

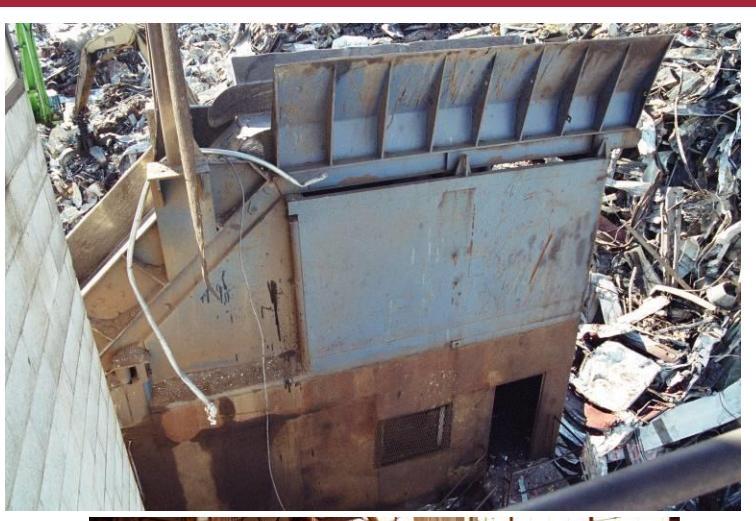
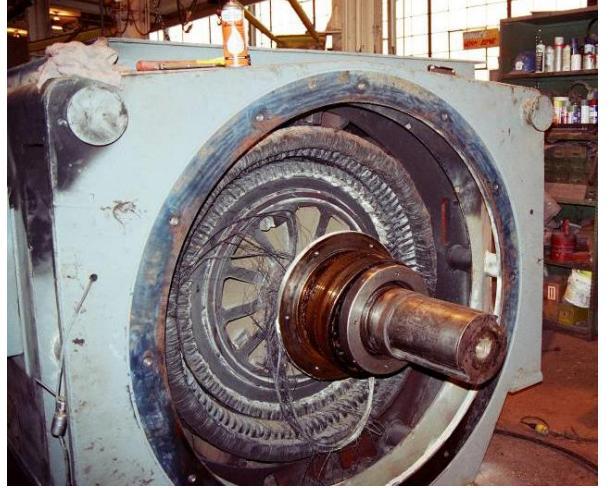
- A plant used a large 2000 HP motor to shred vehicles
  - Operator started early
  - Ran the shredder until 10:30 AM
  - Noticed smoke from the building housing the motor
  - Ran down and discovered a fire in the motor

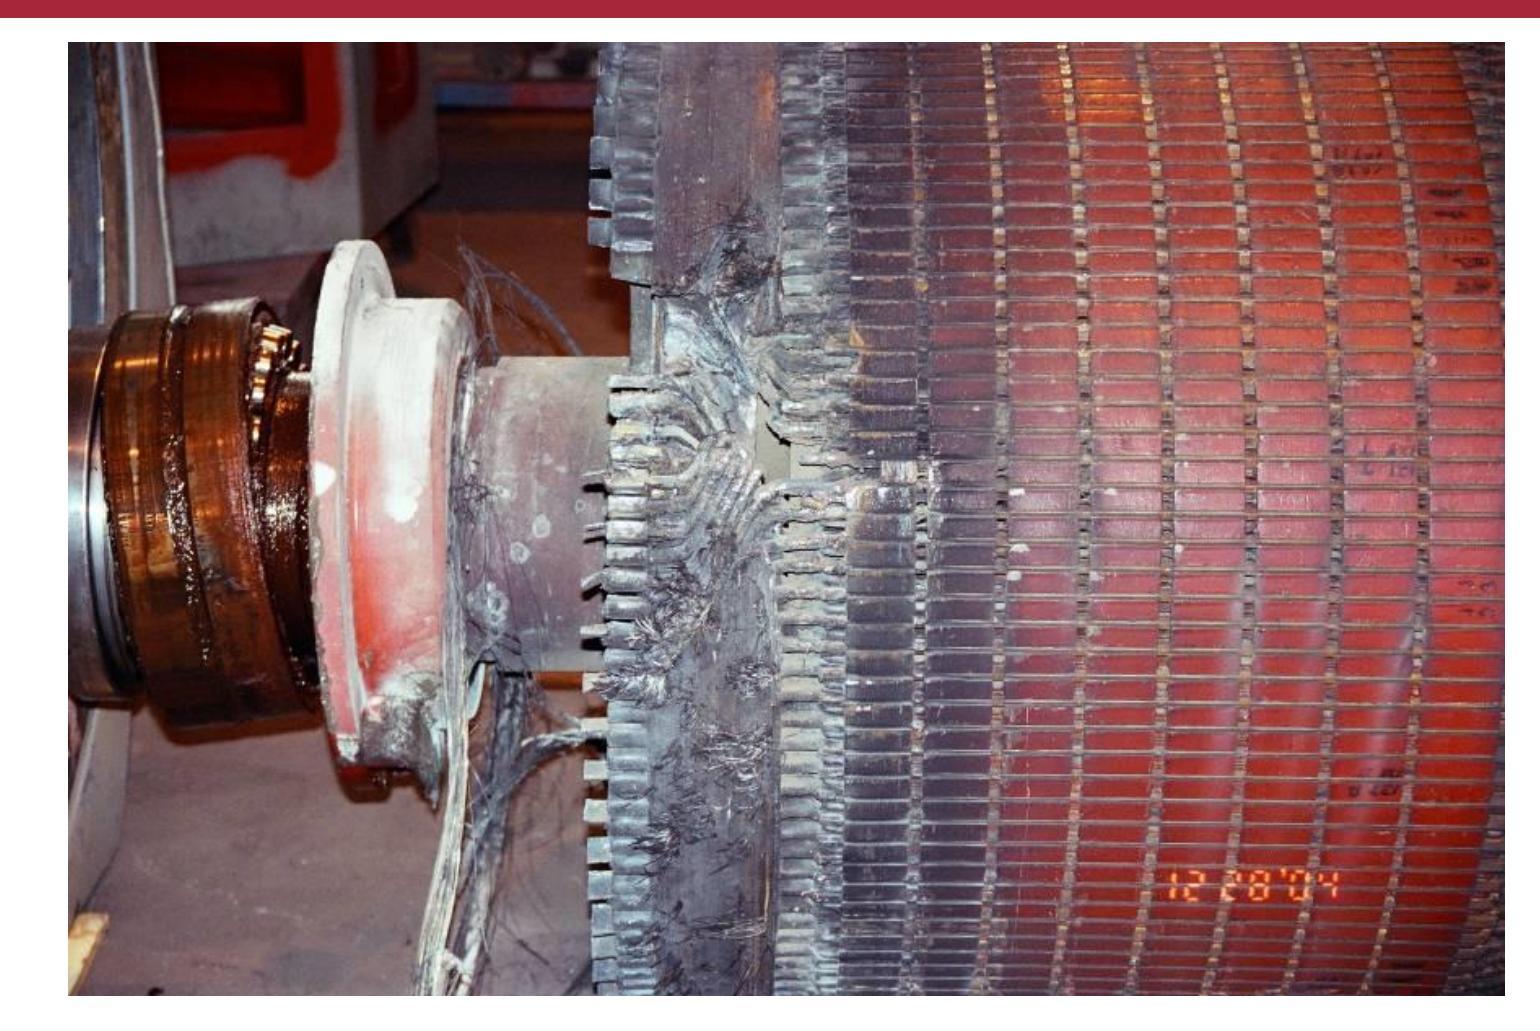
### **Cause: Insulation Failure**

- Eliminated all causes <u>but</u> Failure due to improper manufacturing
- Tests should have detected failure earlier, <u>if</u>
  <u>performed properly</u>
