Escape of Oil – Claim case studies

CILA Property Special Interest Group

January 2020

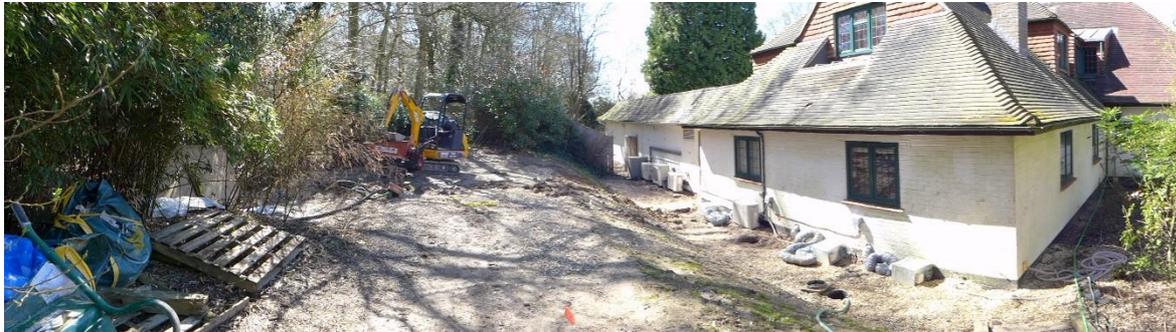
Excavations were to a depth of 1-1.5m and removed approximately 70 tonnes of soil during the full excavation phase of this claim.

Ground water recovery, sump pumps were installed to recover product from ground water at depth. The pumps have to be able to float in their excavated chamber to allow for the ever moving depth of the water table. With kerosene floating on water the pumps skim the product and pump it back to the surface into a mobile treatment plant.
