**Root Cause Analysis**

#### **BLADE FAILURE**

Wolverhampton – UK, 2011

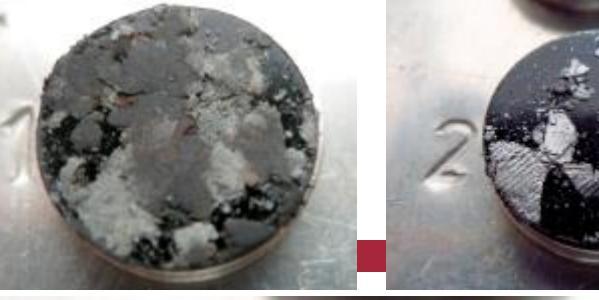
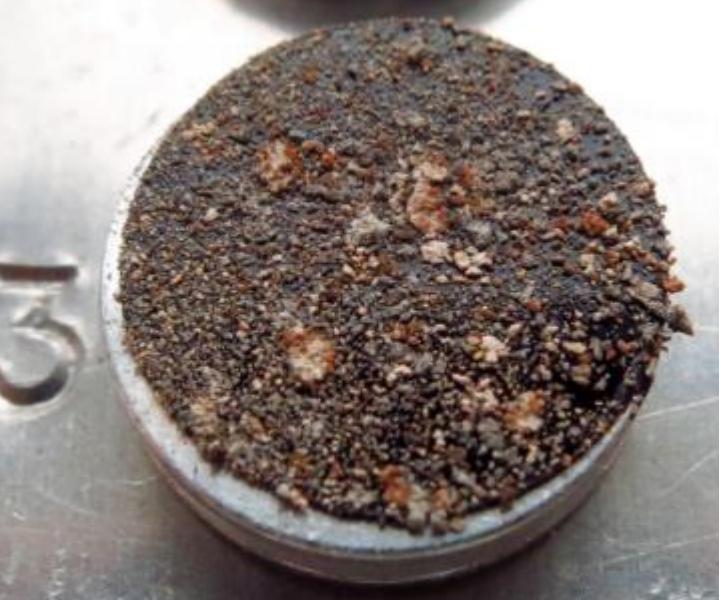
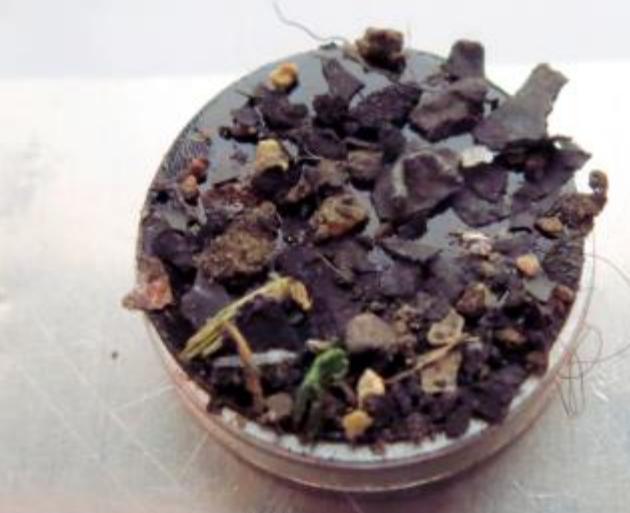
Sample Number and Location	Description	SEM EDX Identification	Most Likely Source	
	1) Steam input screen	Flaking deposits	Mostly iron oxide	Steel corrosion

2) Steam control valve	Film on surfaces and flakes at edges	-Some lead particles (200x75µm)	-Lead/copper particles could be wear particles from a bearing or gasket material.	
			-Some copper particles with lead (50x40µm)		
			-Silica and oxygen	-The silica and oxygen particles are likely to be from steam water contamination	
			(some 140x140μm, most smaller 50x50μm)		
			-Some ferrous particles (220x70μm)	-Ferrous particles could be wear particles from steel.

3) Intermediate rotors	Scale	-Mostly Silica and oxygen	-Primarily silica build-up from steam water contamination.	
			-Some ferrous particles (80x80μm)	-Ferrous particles could be wear particles from steel.

4) Turbine outlet	Debris particles	-Mostly Iron oxide	-Steel corrosion	
			-With Silica and calcium	-Steam water contamination	
			-Some zinc	-Paint or plating material

5) Boiler feed pump filters	Debris particles	-Mostly Iron Oxide (2x3mm)	-Steel corrosion	
			-Some particles of stainless steel	-Stainless steel wear particles

- Some bronze particles	-Bronze wear particles

- The erosion of the low pressure blades is due to debris from steel corrosion and silica particles being transported by the steam.
  - We identified that the input screen for the steam to the turbine had relatively large openings (~6.5 millimeters) and would not be capable of capturing small particles carried in the steam.

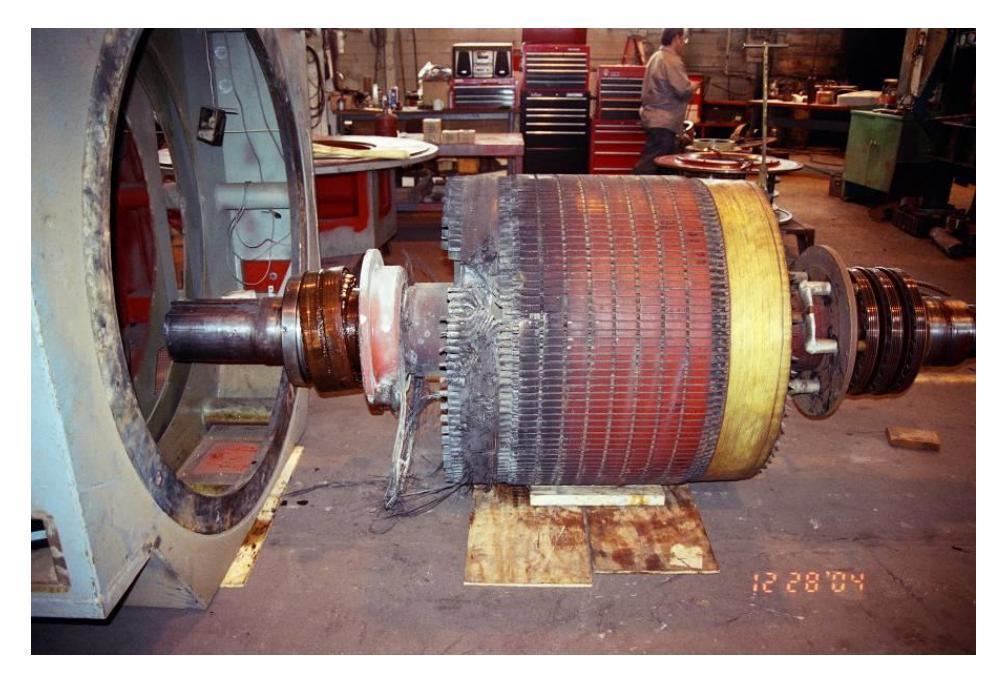
### Inspection

Motor was removed and sent to plant for rewinding

Motor disassembly was assigned to company that performed initial rewinding 2 <sup>1</sup>/<sub>2</sub> years earlier

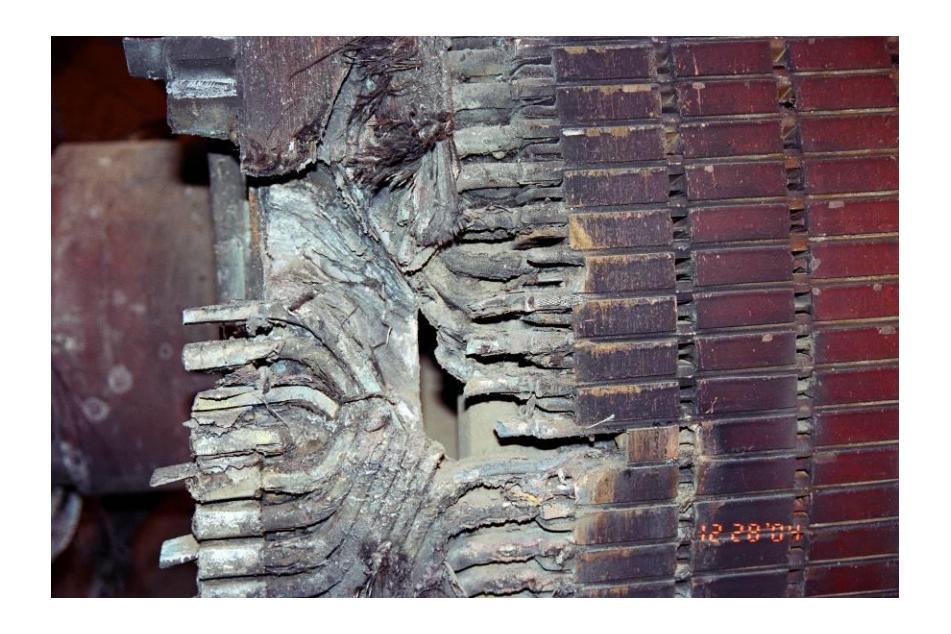
# Manufacturing

- Motor was re-wound
  2 <sup>1</sup>/<sub>2</sub> years earlier
- Operated one shift (8-10 hours)

- Eliminated all causes <u>but</u> Failure due to improper manufacturing
- Tests should have detected failure earlier, <u>if</u>
  <u>performed properly</u>
